**Flood Control Project Maintenance
Levee Inspections****LMA District Cover Sheet
Spring 2015 Levee Inspection Results****Reclamation District No. 2104 Peters Pocket Tract**

Spring 2015 Levee Inspection Results

Reclamation District No. 2104 Peters Pocket Tract

Waterway			Bank	Unit Miles
Unit No. 01 Cache Slough			Left	6.85
	Spring (March - May)	Summer (June - August)	(September - November) Fall	Winter (December - February)
Unit Maintenance Rating (Fall Only)				
Date of Inspection	04/02/2015 - 04/02/2015			
DWR Inspector	Herman Phillips			
Accompanied By

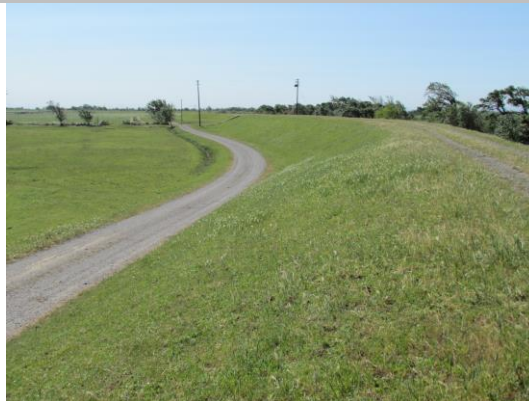
Photo 1 of 1 : SP_2015_RD2104_249_42_20150604_00022.jpg

LM Start	0.00	Rating **	A	Issue No.	42
LM End	0.00	Issue Type +	Ma	Location *	LS
Category	Earthen Levee			GPS Latitude/Longitude	
				Start	End
Item	Vegetation			38.308296 °	38.308296 °
				-121.758594 °	-121.758594 °
DWR ID	DWR_RD2104_01_s_2012_42				
Action/Comments					
Remove the wild growth other than native grasses from the levee slopes.

View looking downstream along the landside slope.

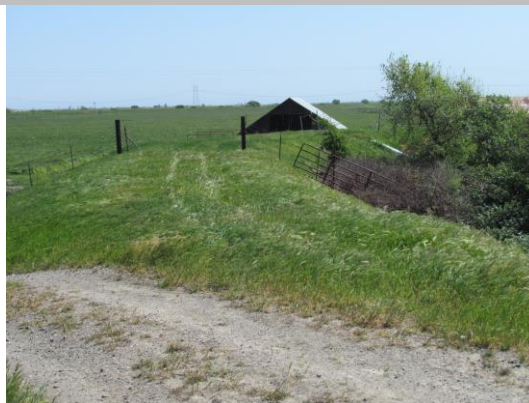
Photo 1 of 1 : SP_2015_RD2104_249_64_20150604_00023.jpg

LM Start	1.38	Rating **	U	Issue No.	64
LM End	1.49	Issue Type +	Ma	Location *	CR
Category	Earthen Levee			GPS Latitude/Longitude	
				Start	End
Item	Vegetation			38.295680 °	38.294765 °
				-121.742522 °	-121.741217 °
DWR ID	DWR_RD2104_01_s _ 2015_64				
Action/Comments					
Keep the crown roadway free of vegetation. Inspector Comments: Keep the crown roadway free of all vegetation.

View looking downstream at the crown roadway.

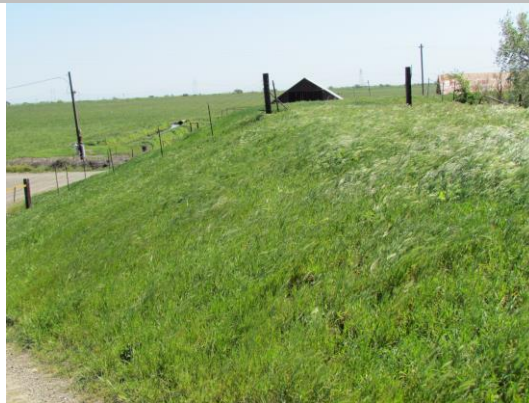
Photo 1 of 1 : SP_2015_RD2104_249_43_20150604_00024.jpg

LM Start	1.38	Rating **	U	Issue No.	43
LM End	2.99	Issue Type +	Ma	Location *	LS
Category	Earthen Levee			GPS Latitude/Longitude	
				Start	End
Item	Vegetation			38.295688 °	38.298662 °
				-121.742488 °	-121.730313 °
DWR ID	DWR_RD2104_01_f _ 2014_43				
Action/Comments					
Control annual grass and weeds on the levee slopes and easements. Inspector Comments: Unacceptable weeds on the landside levee slope.

Unacceptable weeds on the landside levee slope.

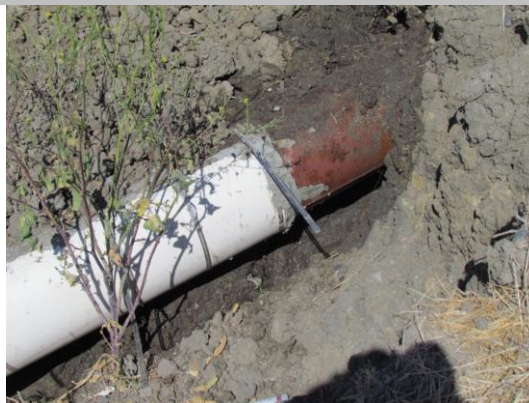
Photo 1 of 2 : SP_2015_RD2104_249_120_20150312_00010.jpg

LM Start	4.01	Rating **	M	Issue No.	120
LM End	4.01	Issue Type +	En	Location *	LS
Category	Earthen Levee			GPS Latitude/Longitude	
				Start	End
Item	Encroachments			38.310912 °	38.310912 °
				-121.736172 °	-121.736172 °
DWR ID	DWR_RD2104_01_f_2014_120				
Action/Comments					
Pipe					
Inspector Comments: The landowner is working with CVFPB authorizing the work on this pipe.

View of pipe on landward side. Water is shown coming through levee around pipe.

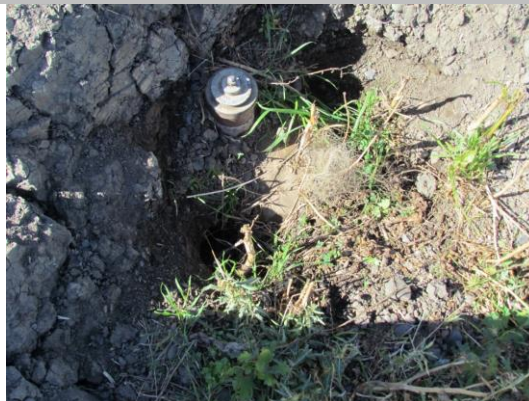
Photo 2 of 2 : SP_2015_RD2104_249_120_20150312_00011.jpg

View of the unauthorized pipe work. The siphon breaker on the waterward side has water running under pipe back through levee.

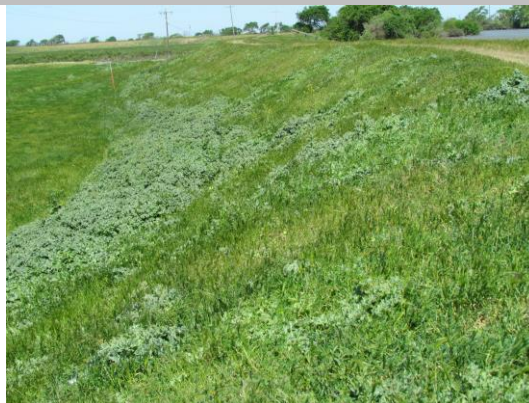
Photo 1 of 1 : SP_2015_RD2104_249_122_20150604_00026.jpg

LM Start	4.24	Rating **	U	Issue No.	122
LM End	4.71	Issue Type +	Ma	Location *	LS
Category	Earthen Levee			GPS Latitude/Longitude	
				Start	End
Item	Vegetation			38.313130 °	38.318388 °
				-121.739050 °	-121.744370 °
DWR ID	DWR_RD2104_01_f_2014_122				
Action/Comments					
Remove the wild growth other than native grasses from the levee slopes.

Unacceptable weeds on the landside levee slope.

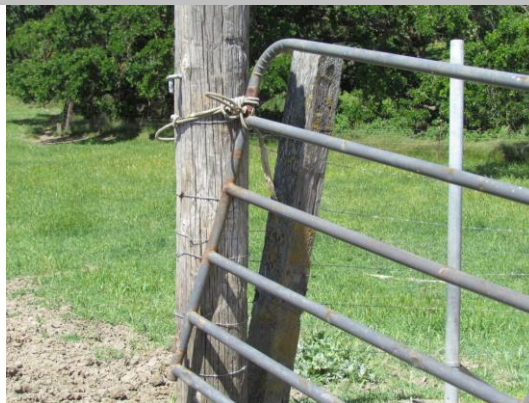
Photo 1 of 1 : SP_2015_RD2104_249_73_20150312_00008.jpg

LM Start	5.29	Rating **	U	Issue No.	73
LM End	5.29	Issue Type +	Ma	Location *	CR
Category	Earthen Levee			GPS Latitude/Longitude	
				Start	End
Item	Repair Gates			38.323281 °	38.323281 °
				-121.751272 °	-121.751272 °
DWR ID	DWR_RD2104_01_s_2014_73				
Action/Comments

Repair this gate.
